An Examination of Man Made Radio Noise at 37 HF Receiving Sites

Wilbur R. Vincent
Richard W. Adler
and
George F. Munsch

November 2003

THE MITIGATION OF RADIO NOISE FROM EXTERNAL SOURCES

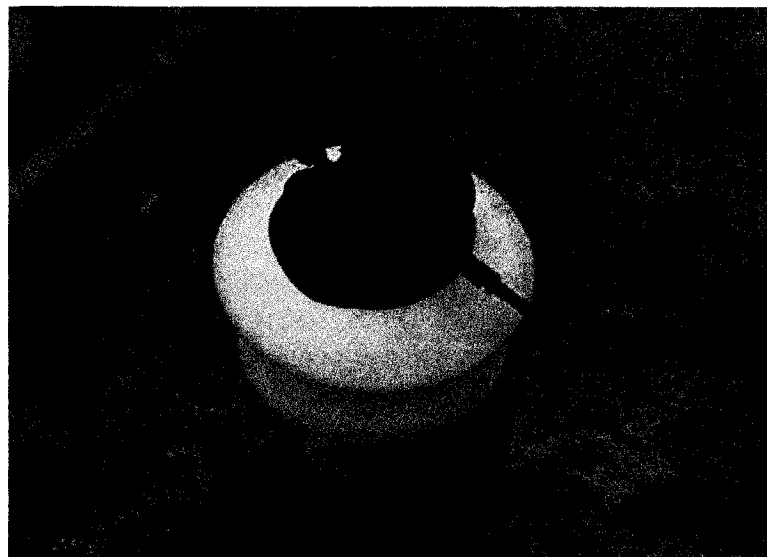
Figure 36 Insulated Tie Wire on a Bare Conductor

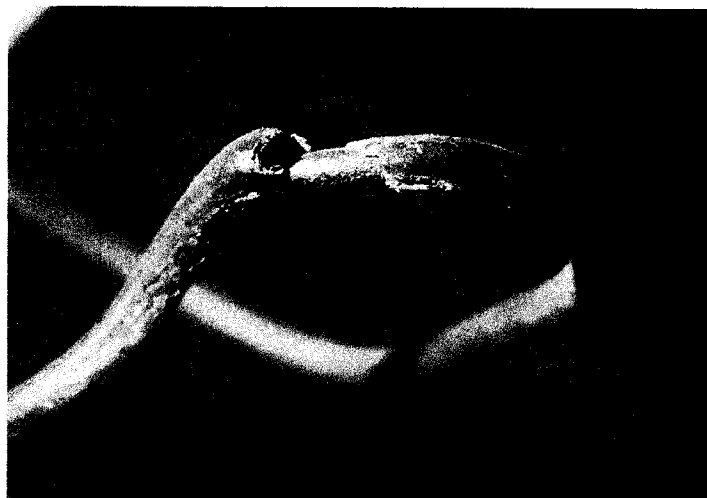
Figure 37 Insulation Failure at a Bend in a Tie Wire

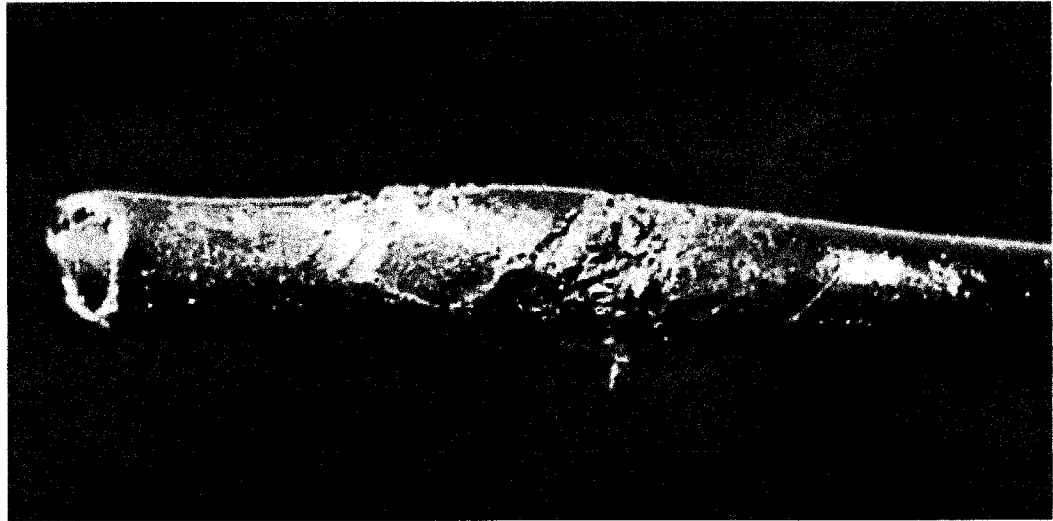
Figure 38 Insulation Failure at the End of a Tie Wire
